Proposals for Future Conservation Actions

Testing of Stone and Masonry Conservation Techniques and Materials

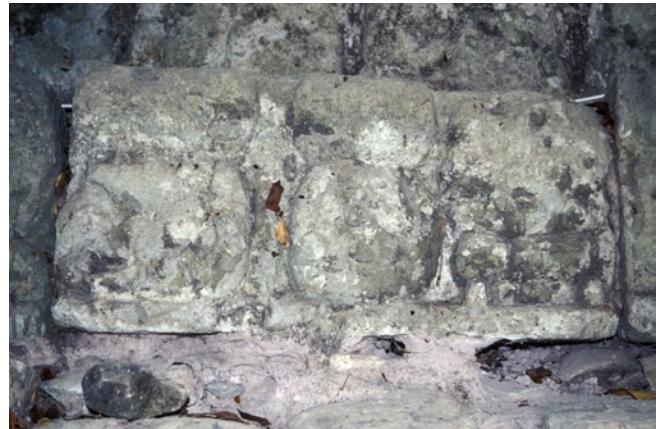
Figure 95 Block 408, step 43. Previous consolidation treatments, biological growth, and loss of repointing mortar can be seen.

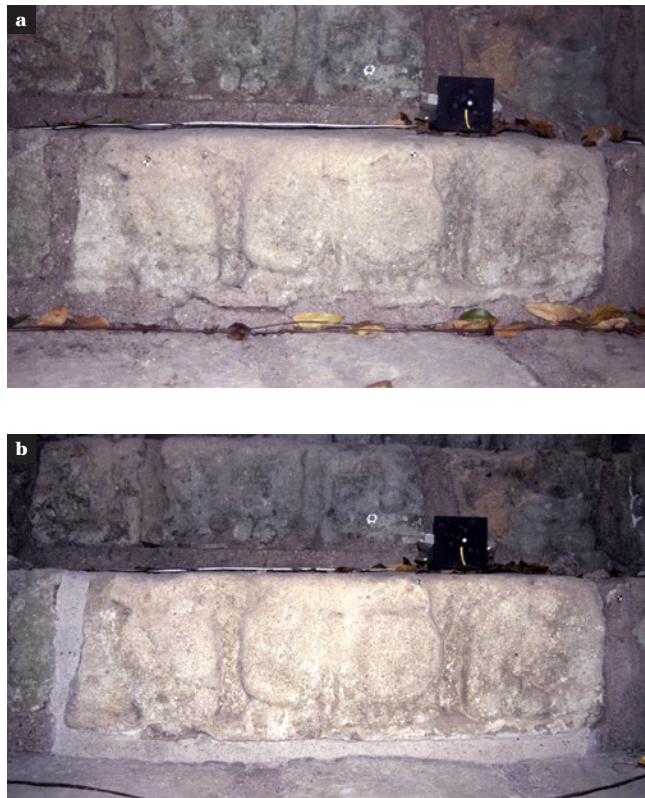
More than two years later, the two repointing mortar tests of blocks 406–407 and 488 were in good, unchanged condition. Either of these mortars, made with locally available materials and without any synthetic additives, could be used on the Stairway with adequate results, both functionally and aesthetically.

Figures 105a and b Treatment trial block 488, step 52, before (a) and after (b) mortar removal and repointing.

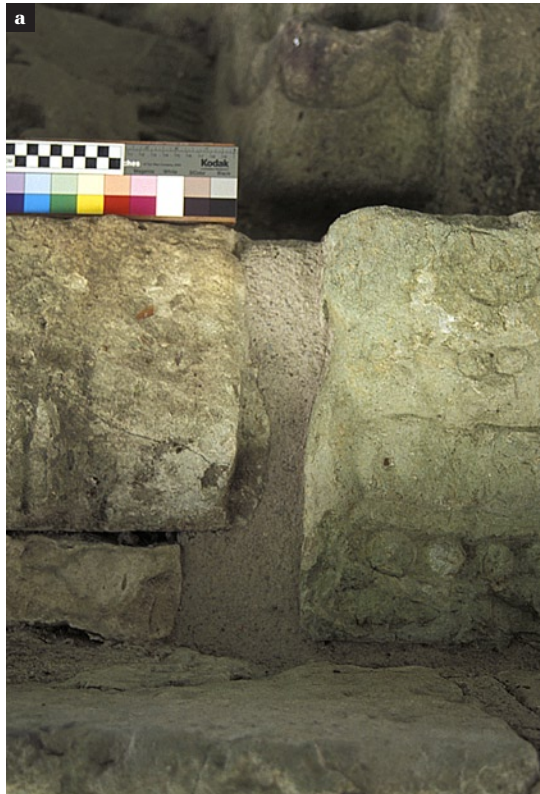
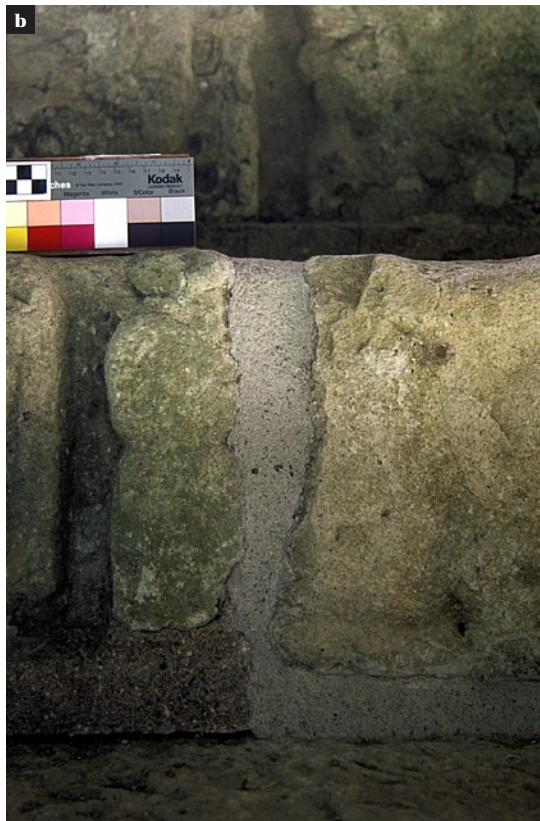
Figures 106a and b Comparison of two trial mortars for repointing: for block 406, step 43, the mortar was chosen to match the existing joint mortar (a); for block 488, step 52, the mortar was chosen to blend in with the variety of block colors (b).

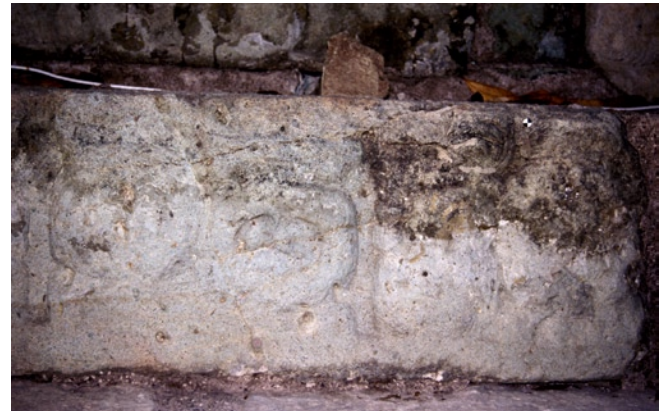
Figure 107 Treatment trial block 463, step 50, glyphs F and G, shown after the cleaning of glyph F (on the left) with water and a light toothbrushing; glyph G (on the right) has not been cleaned.

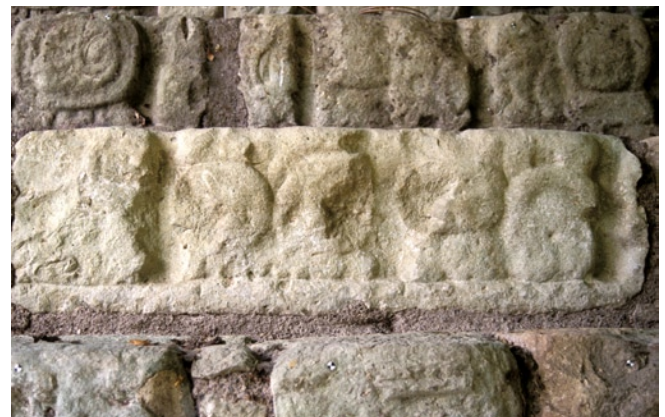
Figure 108 Treatment trial block 197, step 23, shown after cleaning with water and a light toothbrushing.

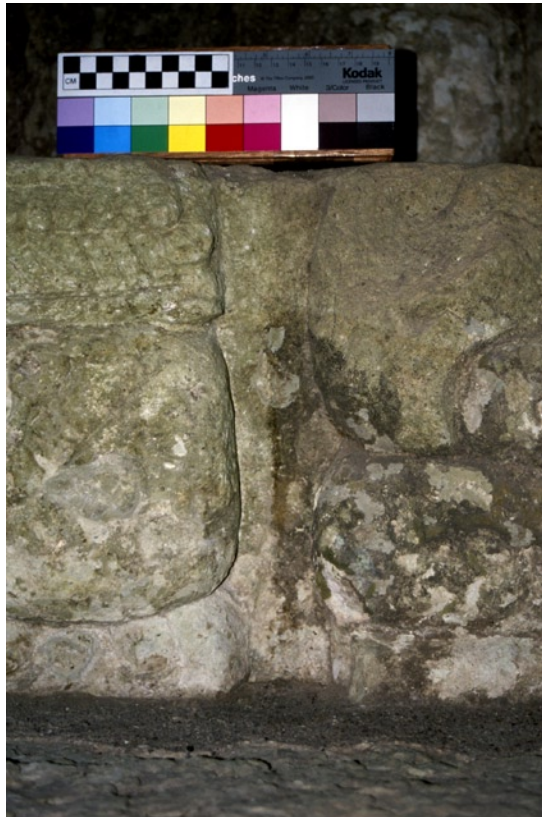
Figure 110 Stone surface shown after reduction of darkened consolidant (on the left); the procedure has not been performed on the right side.

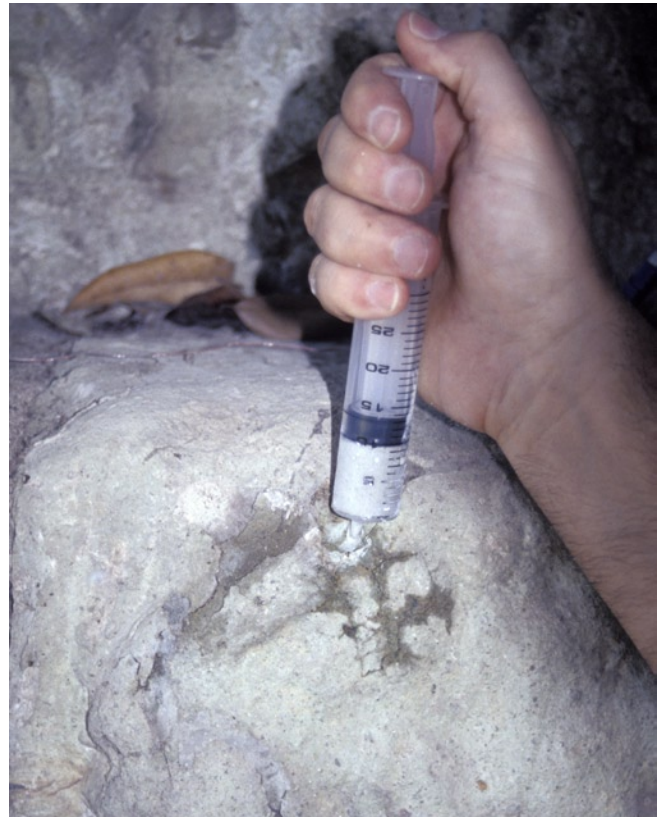
Figure 111 Grouting of a detached area of block 71, step 11, with a lime-based liquid mortar.

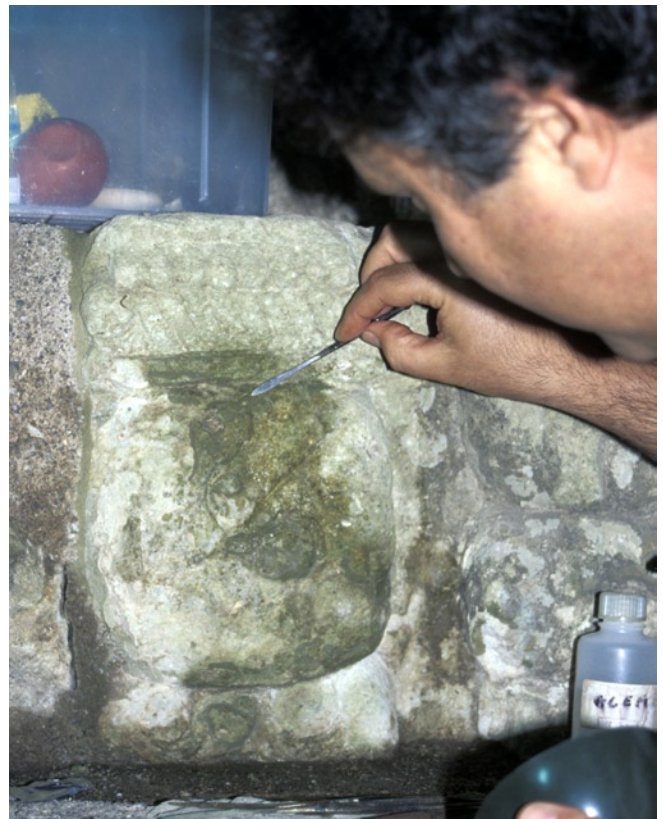
Figure 112 Edging flakes on block 578, step 61, with a lime-based mortar.

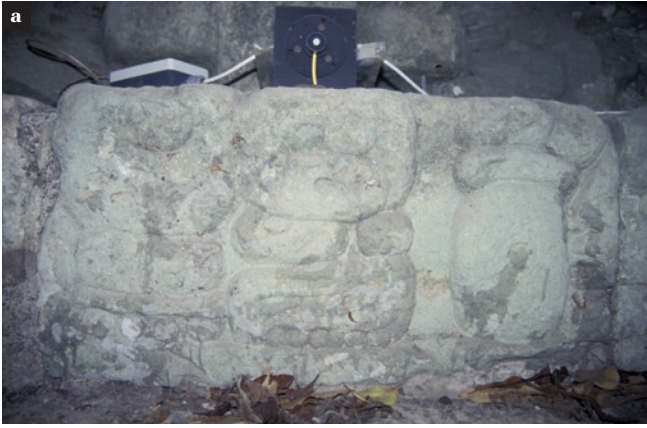
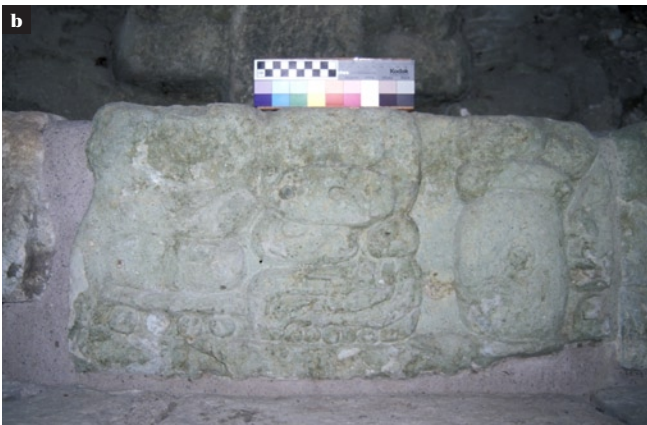
Figures 113a and b Treatment trial block 406, step 43, before (a) and after (b) treatment. There is an improvement in readability of surfaces after reduction of darkened consolidant from previous treatments and stabilization with edging repairs and with fills of lime-based mortars, colored with pigments to match the stone.

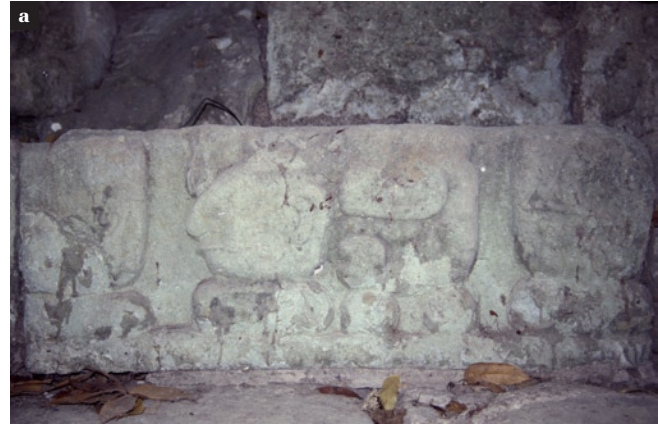
Figures 114a and b Treatment trial block 407, step 43, before (a) and after (b) treatment. There is an improvement in readability of surfaces after reduction of darkened consolidant from previous treatments and stabilization with edging repairs and with fills of lime-based mortars, colored with pigments to match the stone.

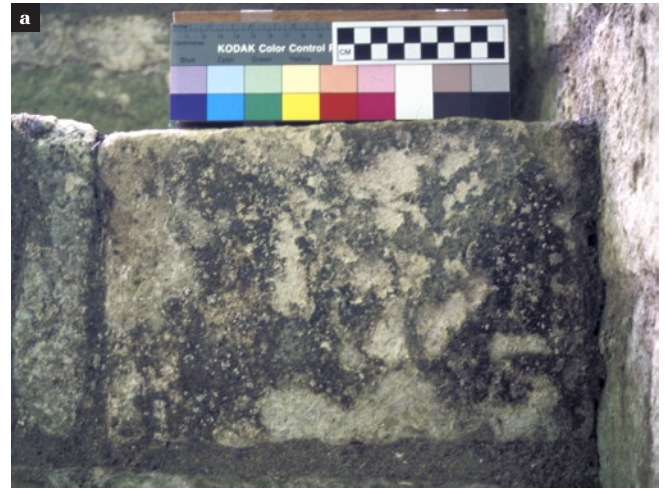
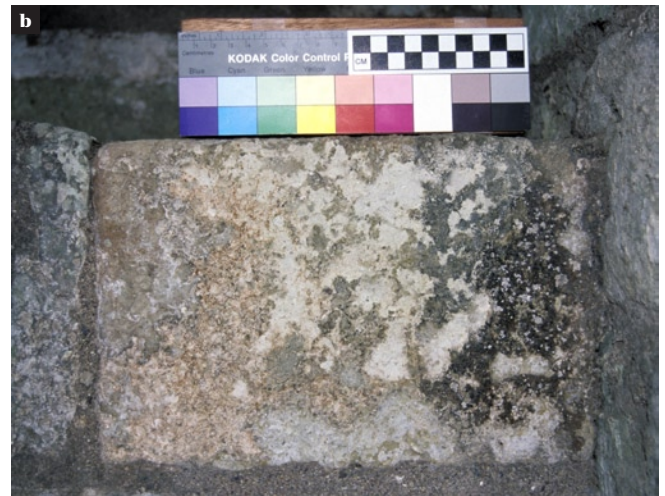
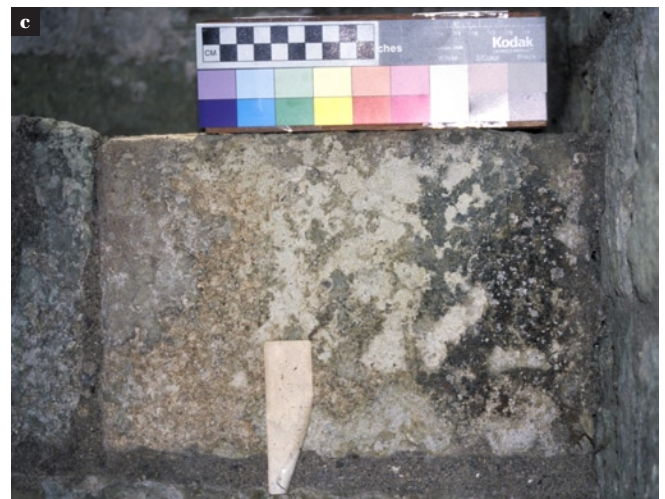
Figures 115a–c Uncarved block 68-2e, from the reconstructed upper steps, before treatment (a), after water cleaning of the left two-thirds (b), and eight months after the application by brush of Syton x-30 in distilled water (c) (left of tape, concentration 1:1; right of tape, 1:2).

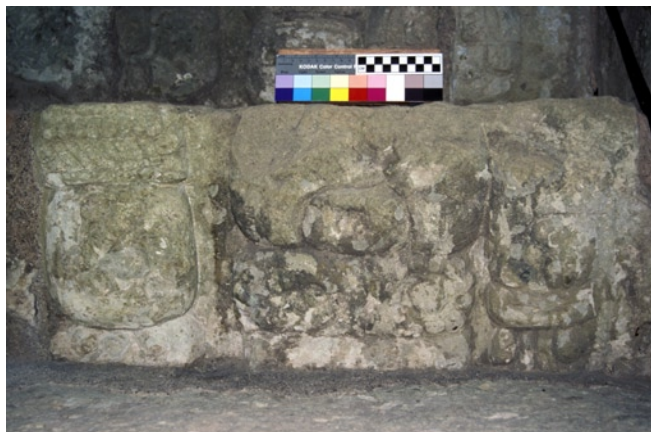
Figure 116 Treatment trial block 578, step 61. Glyph Q, on the left, is shown after reduction of previous treatments and new stabilization treatments; glyph R, on the right, shows the darkening over time of previous stabilization treatments.

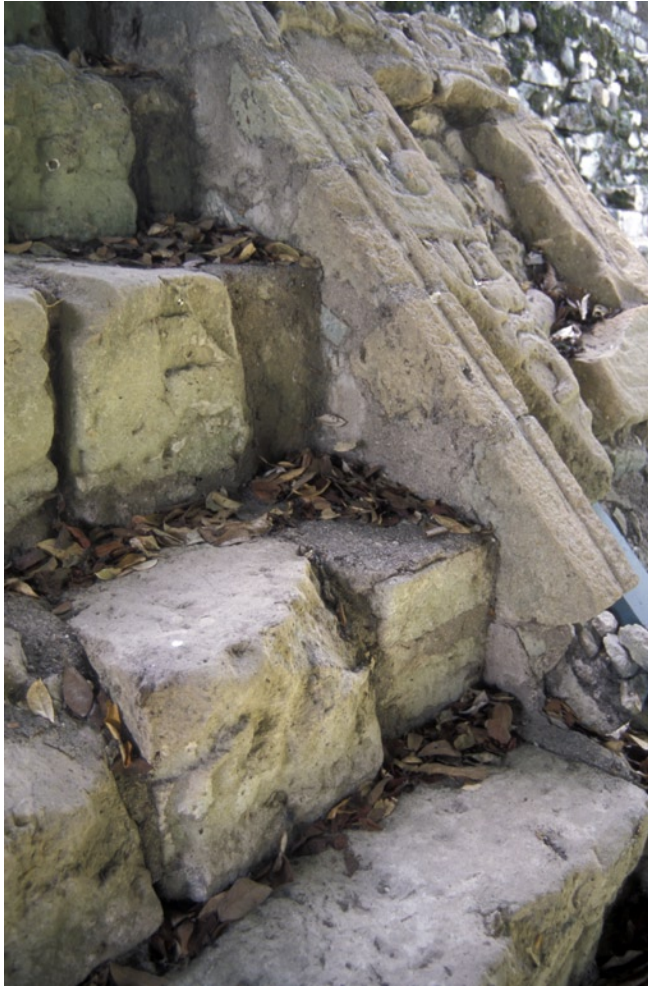
Figure 121 Accumulation of leaves on the south side of the bottom portion of the Stairway.

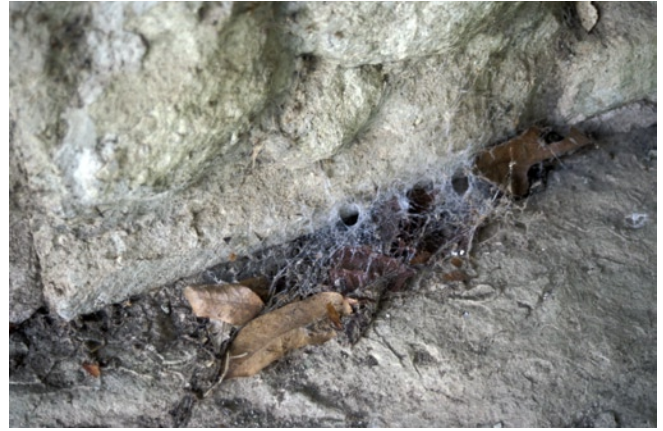
Figure 122 Spiderwebs and leaves on the steps of the Stairway.

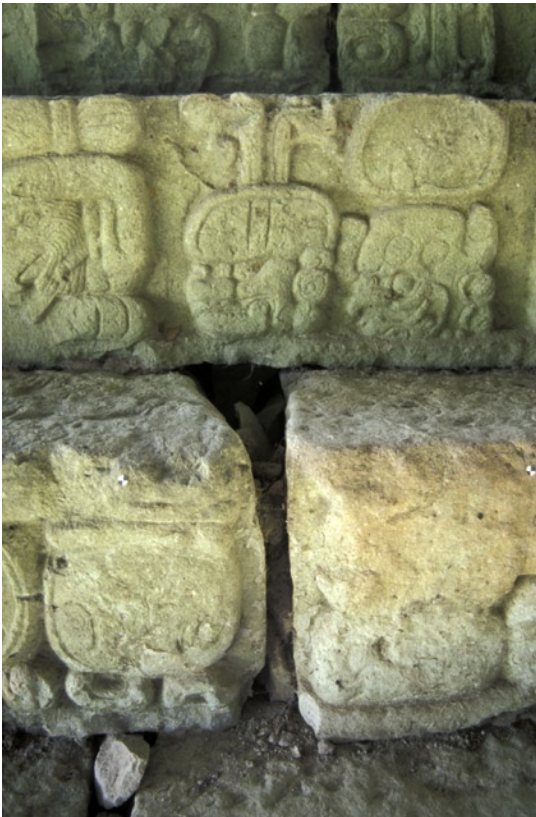
Figure 124 Area of mortar loss between blocks caused by burrowing animals.

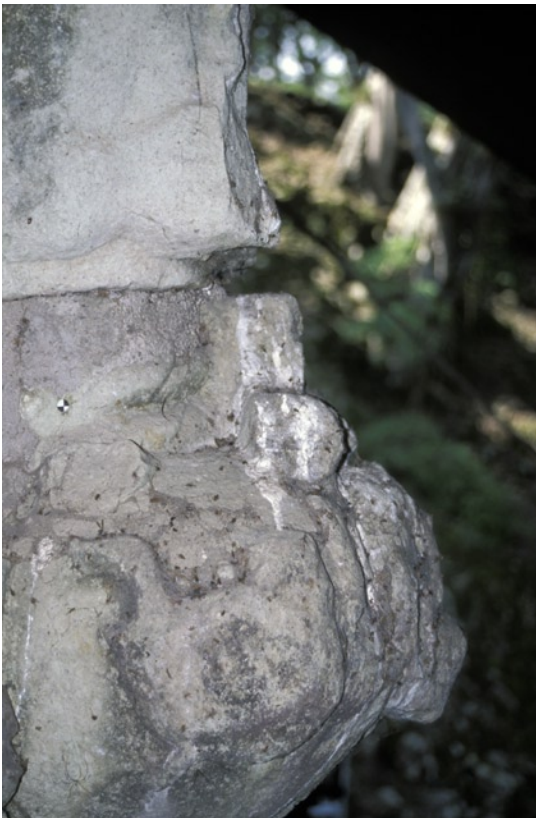
Figure 125 A Seated Figure used by birds as a perch. Guano can be seen on the carved surface.

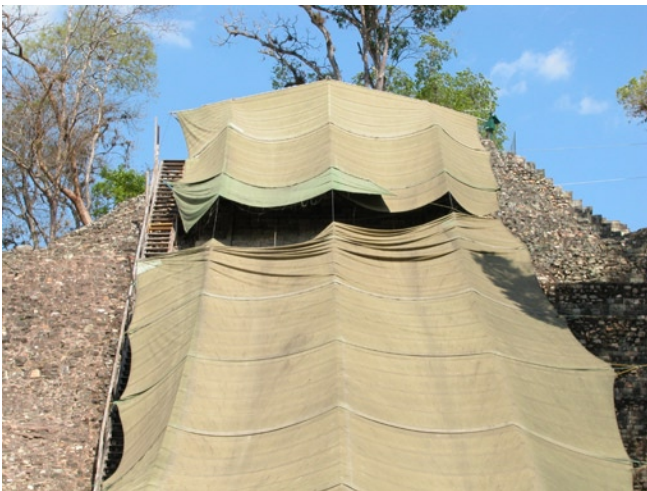
Figure 132 The shelter, which was installed in February 2001, with a tear caused by high winds in 2005, in the same location where the tarpaulin was previously repaired.

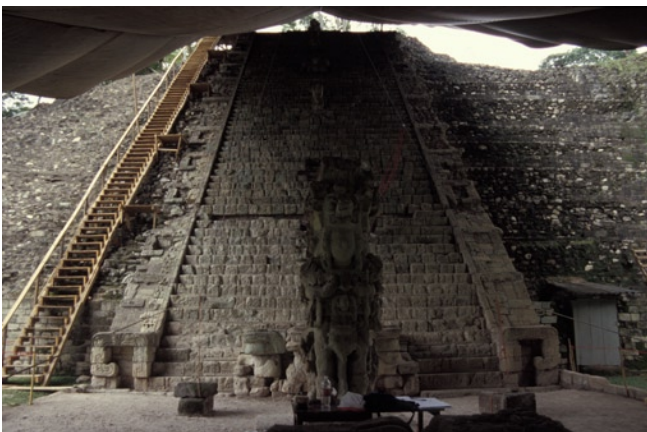
Figure 133 View from the Plaza, as the public sees the Hieroglyphic Stairway. The visibility of the upper portion is poor because of the contrast between the bright sky and the dimly lit upper part of the Stairway.

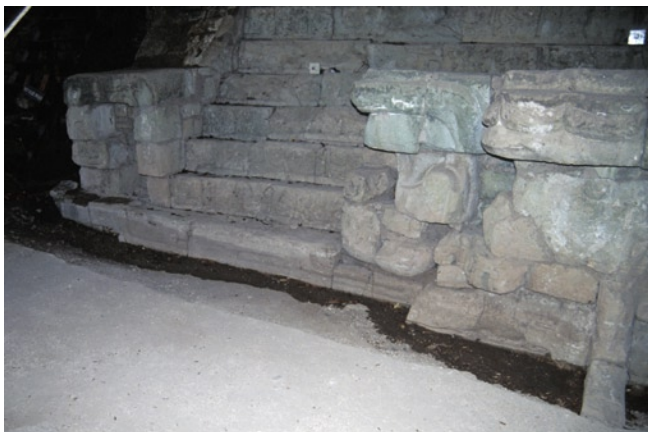
Figure 156 Accumulation of rainwater at the base of the Stairway during a heavy rainstorm.

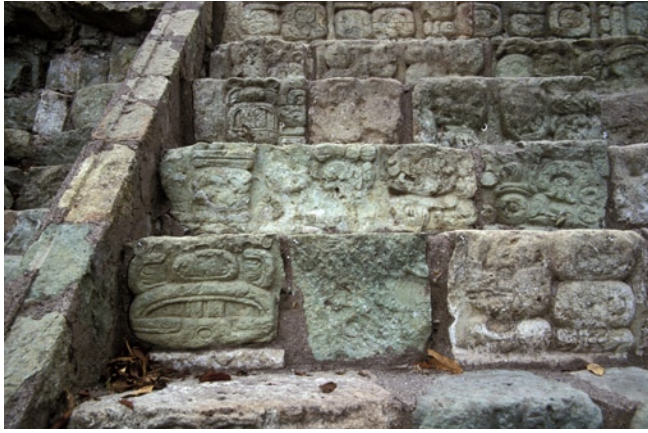
Figure 138 An old crack between the north balustrade and steps 54–58.

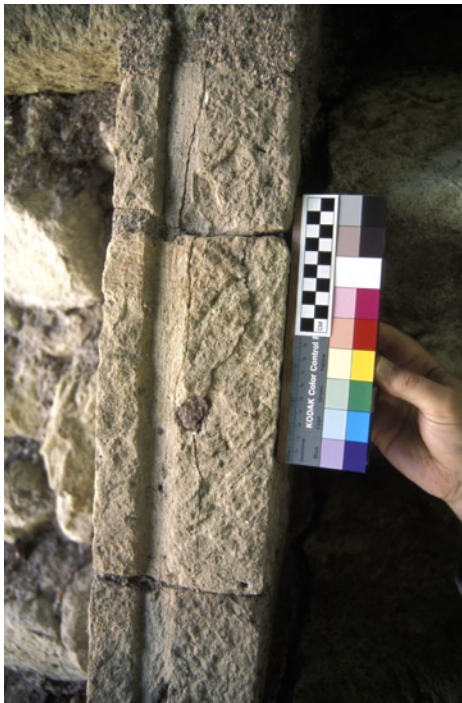
Figure 139 A crack within north balustrade blocks N38 and N39.

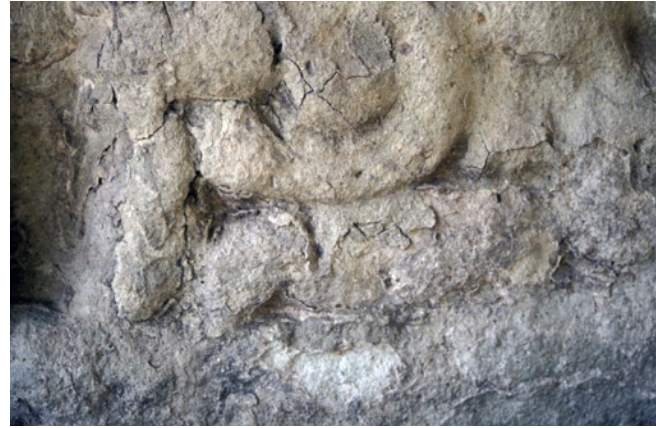
Figure 142 Block 71, step 11, with flaking and detached surfaces that require stabilization.

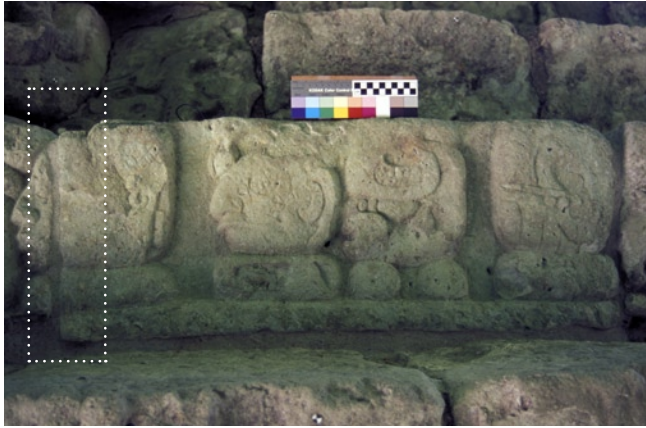
Figure 143 Block 407, step 41, after a trial treatment in which the color of the edging and fill mortar was matched to the stone surface by the addition of mineral pigments to the lime mortar (at the left).

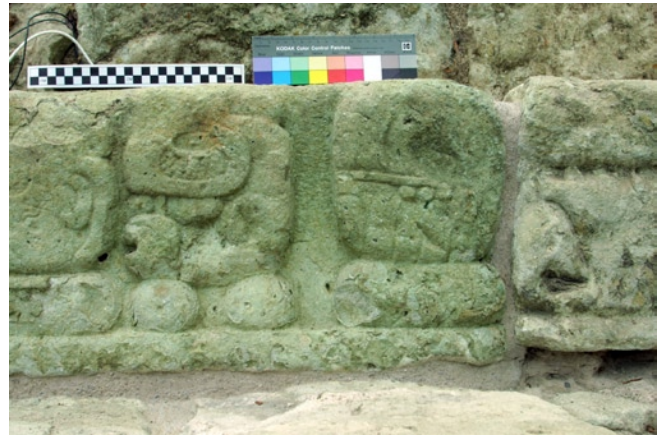
Figure 146 Repointing of treatment trial block 407, step 43 (left), and missing mortar under the adjacent block (right).
